Inspection Report

Zee Home Inspection

Property Address 1111 confidential Avenue, Union, NJ 07083

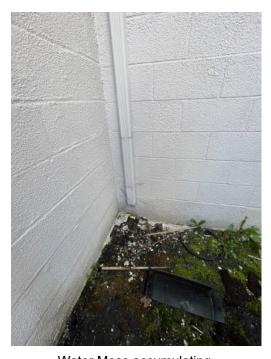
Poor site drainage was observed. We recommend cleaning or fixing drainage areas to assure water drainage is away from the property. Failure to fix or clean drainage system areas at the foundation can cause water seepage under slabs, into the basement/crawlspace, and/or cracks or movement in the foundation. It is suggested that a "Licensed General Contractor" be contacted for further evaluation and repair.

Water Moss accumulating.

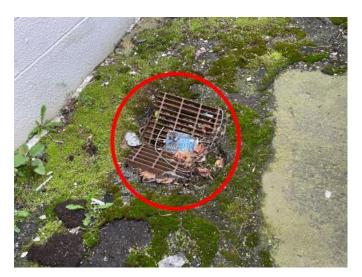
Broken or clogged Drainage.

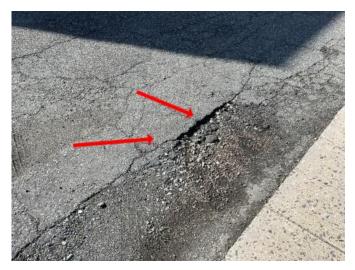
The driveway appeared to be in a serviceable condition at the time of the inspection and appears to be approaching the end of its useful life. It is suggested that a "Licensed General Contractor" be contacted for further evaluation and repair.

Deteriorating driveway.

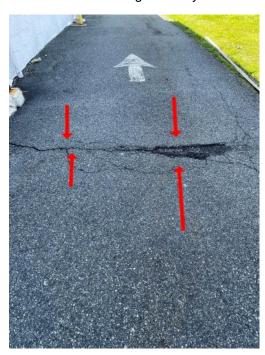
Path-hole Trip hazard.

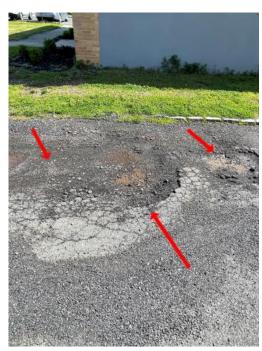
Deteriorating Driveway At front Unit# C.

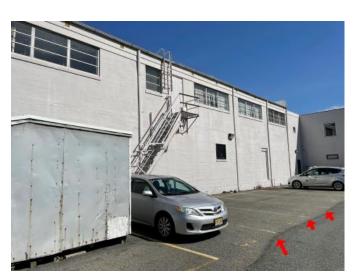
Faded parking lines.

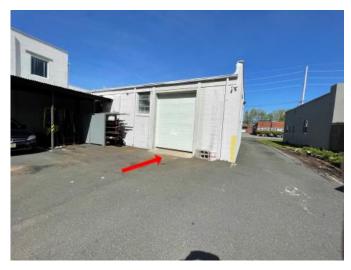
NO Loading/Unloading parking Zone Marking.

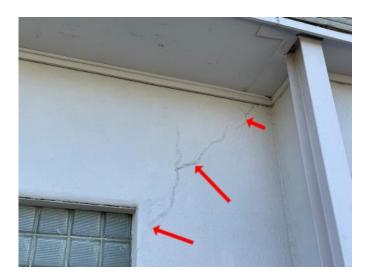
- Some spalling and vertical cracks were observed at the front and East sides of the Buildings
 A, B & C walls.
- Due to conditions observed, further evidence may exist in areas not readily visible or accessible. Water penetration may have occurred.
- Cracks on the walls do not seem to be a major issue at the time of the inspection. it is recommended to monitor the cracks periodically or have them checked by a licensed contractor or structural engineer for further evaluation and repairs.

Building A & B cracks.

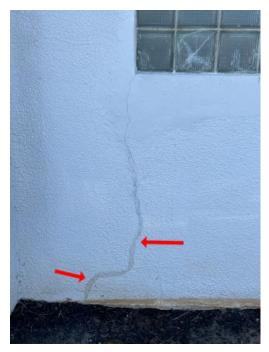
Building A & B cracks front left side.

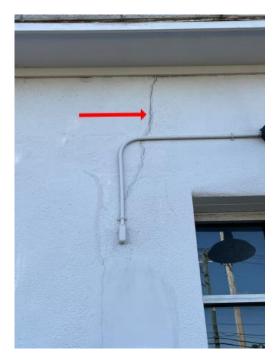
Building A & B cracks Front door.

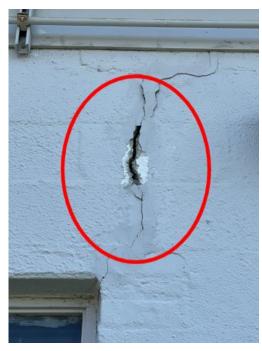
Crack and spalling Building A & B cracks Right side.

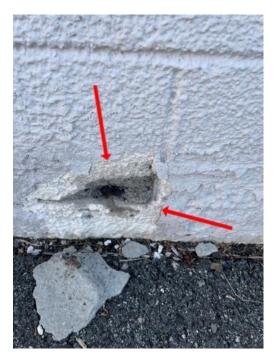
spalling Near outside condenser unit Building# C

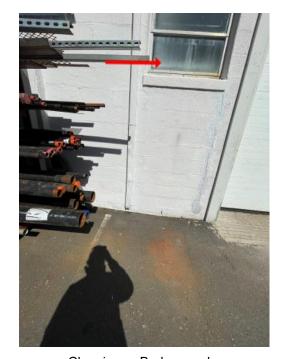
Building A, B, and C Most of the Exterior windows were uncleaned, weathering, and some deterioration was observed like broken glass and drying putty or sealant. Recommend repairs, Replace, or maintenance as needed. It is suggested that a "Licensed Contractor" be contacted for further evaluation and repair or replace.

Cleaning or Broken seals.

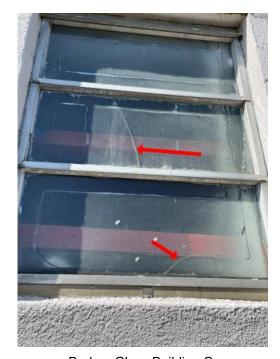
Broken Glass Building C.

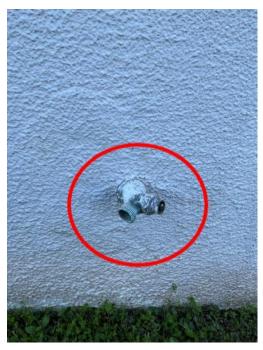
Hose faucet was broken or missing handles at building # C's front side. Need repair or replace with new faucet.

Building# C broken Hose faucet.

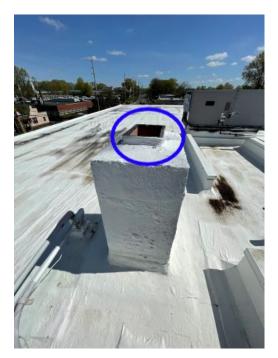
The chimney flue did not have a rain cap installed. Recommend a cap be installed during normal chimney maintenance. It is recommended installation of a rain cap.

Missing Rain Cap Building A & B Roof.

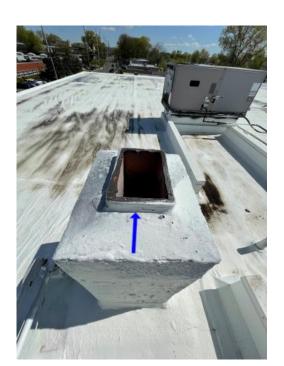
Missing Rain cap.

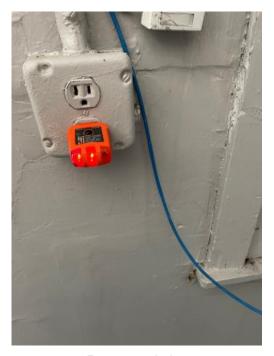
Reverse polarity.

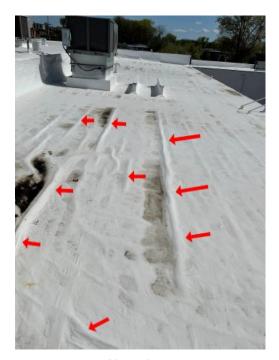
The roof had evidence of unprofessional installation i.e low sloping, air pocketing, and water ponding. Given this condition, it is likely that the roof's age will be less long than expected. Recommend asking the seller if they have any Roof warranty or guarantee for future concerns.

Air pockets.

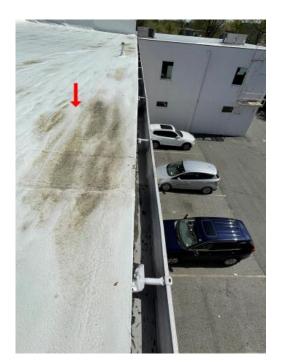
Water ponding.

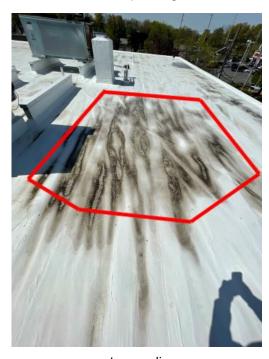
water ponding.

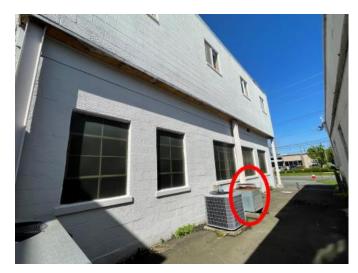
Abandoned Unit.

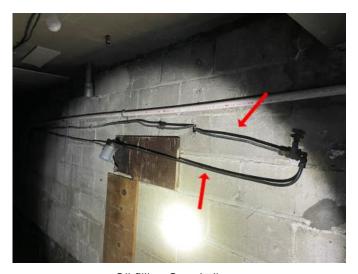
Oil heating supply lines were noticed in the basement, which is strong evidence of Oil tanks buried or above the ground inside or outside the building. it is recommended to ask sellers if they have any documentation of removal or remediation of the Oil heating tank above or underground otherwise scan the property for any oil or storage tank buried inside or outside the buildings.

Oil filling Supply lines.

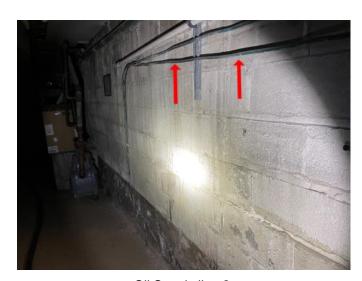
Oil Supply line 2.

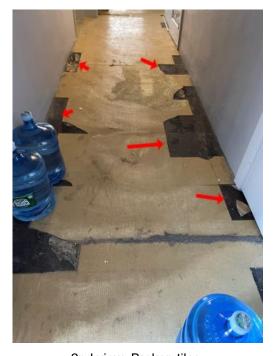
Buildings A floors, The general condition of the visible and accessible portions of the floors appeared to be in a serviceable condition at the time of the inspection. The floor coverings were damaged on the first floor of building A. Recommend repairs. It is suggested that a "Licensed General Contractor" be contacted for further evaluation and repair.

2nd view. Broken tiles.

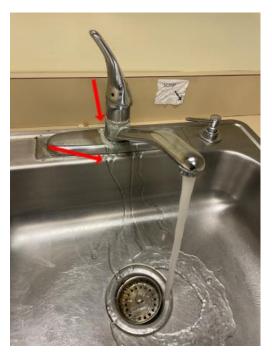
- Building A kitchen sink faucet leaked/dripped at the time of the inspection. Repair is recommended.
- Building B and Building C kitchens were Inspected and no Major deficiencies were noted at the time of the inspection.

Kitchen Building A.

Leaking faucet upper floor kitchen.

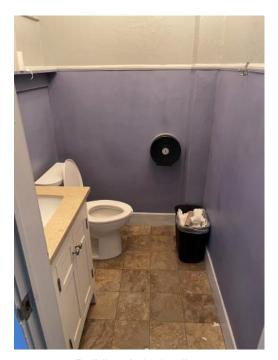
Appear serviceable at the time of the inspection. Most of the toilets were leaking or were loose in building A. Recommend repair. It is suggested that a "Licensed Plumbing Contractor" be contacted for further evaluation and repair.

Building A. leak toilet.

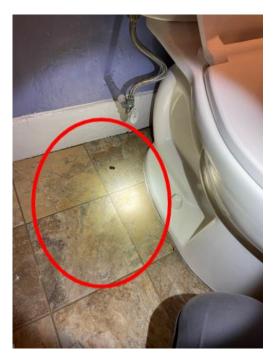
Building A. leak toilet.

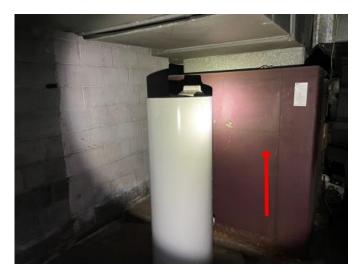
- Building A There were old abandoned oil heating furnace noticed in the basement.
- Building A There were old abandoned electric panels and electric sub panels were noticed.
- It is suggested that a "Licensed Contractor" be contacted for removal.

Abundant Furnace.

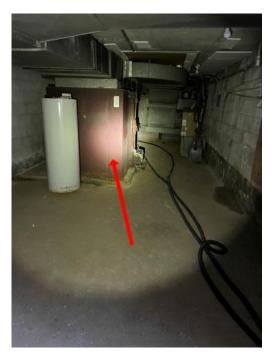
Abandoned Furnace.

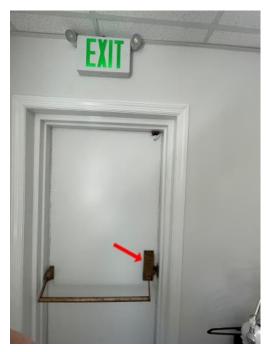
- At building A and B, There were multiple means of egress. No deficiencies were noted at the time of the inspection,
- At building B upper floor egress door lock was not functioning properly needs maintenance as needed.
 Safety.

Egress lock upper floor Building C.
