Inspection Report

Zee Home Inspection

Property Address XYZ St Somewhere, NJ 00000

Inspection Date 10/13/2023

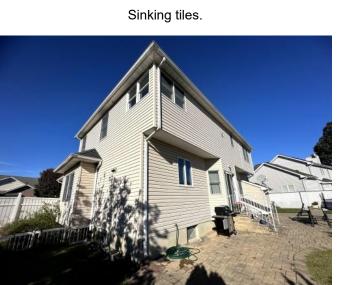
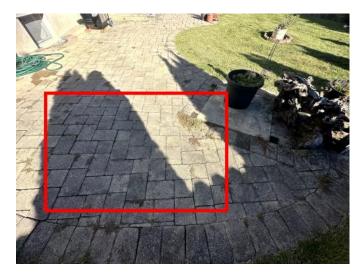
1.5) Patio Deck Conditions

- Some back door patio tiles were sinking noticed at the inspection time. Water erosion is one of the most common reasons for a patio to sink or dip over time.
- This soil can be affected by water erosion causing a dip in your patio. Recommend A "Licensed Contractor" is suggested to be contacted for further evaluation and repair or to obtain examination and analysis by a qualified professional, tradesman, or service technician.

Sinking tiles.

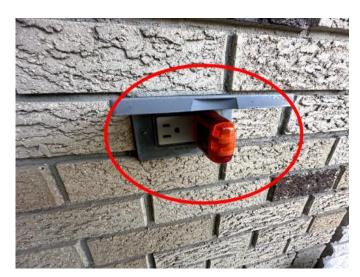
Front door Outlet.

• The front door outlet appeared to be in serviceable condition at the time of the inspection. No power was detected during the test. A "Licensed Electrical Contractor" is suggested to be contacted for further evaluation and repair or to obtain examination and analysis by a qualified professional, tradesman, or service technician.

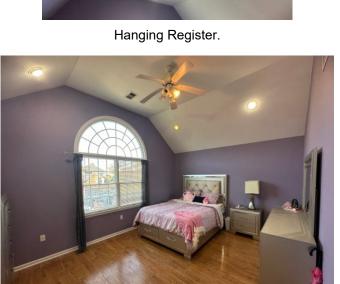
4.2) Distribution Conditions

• The upper-level room ceiling register grill was hanging, Repair or secure them for safety reasons.

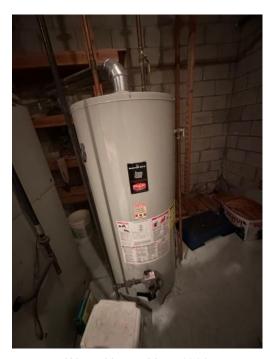
- The Bradford White water heater was installed or manufactured in the **year 1998 or 1999.**Tested and in working condition on the inspection day.
- Inspected and no Major deficiencies were noted at the time of the inspection. Based on the
 manufacturer's suggested service life, the life expectancy of a water heater is about eight to
 12 to 15 years. That varies with the unit's location and design, installation quality,
 maintenance schedule, and water quality.

Water Heater Year 1998

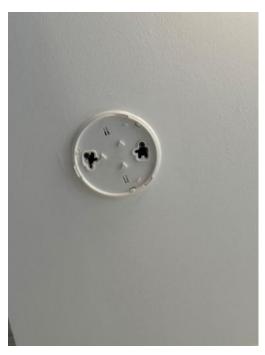
• A smoke detector was missing or removed at the lower level. Recommend smoke detectors on each level and near or in each bedroom. The client should contact the local Fire Marshall's office for proper locations.

Missing smoke alarm.

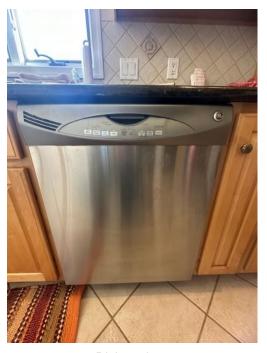
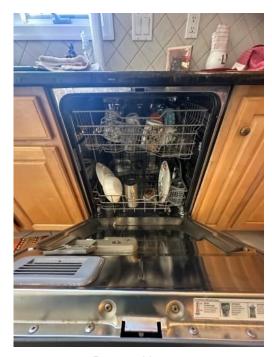
• The dishwasher was not inspected due to personal items inside. Home inspectors are not allowed to remove personal items from any appliance or closet. It is recommended to check again on your final walkthrough or ask the seller before closing.

Personal items.

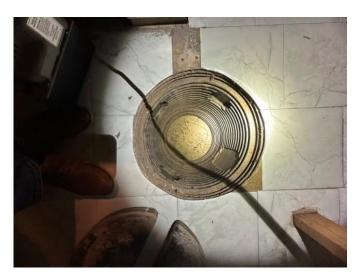
• A sump pit was present. No sump pump was present and no water was observed at the time of inspection. This is not however an indication of future conditions. Whenever a sump pit is present, installation of a sump pump should be considered especially if water becomes present in the pit. Periodic inspection is recommended after a rainstorm.

Sump pit no water.

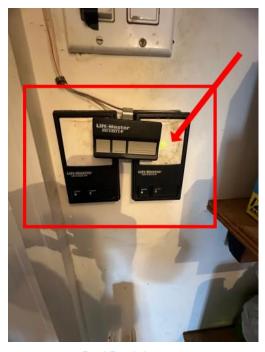
• Both Garage door automatic openers were not operational or disconnected at the time of the inspection. Repair, replacement, and/or adjustments are needed.

Bad Push button.

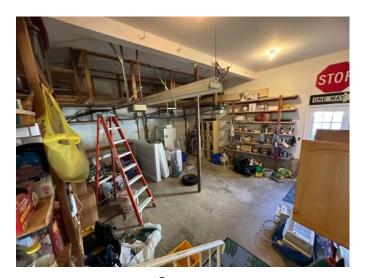
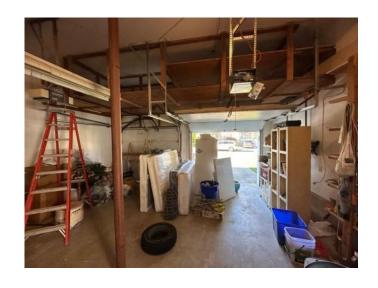
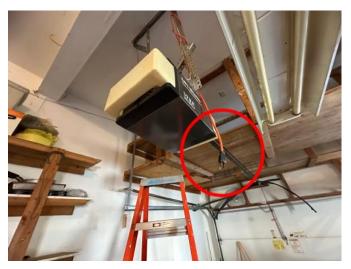
Disconnect connection
