Inspection Report

Zee Home Inspection

Property Address 1111 confidential Avenue, Union, NJ 07083

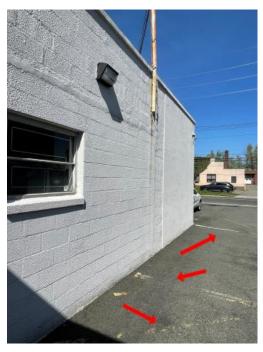
Inspected and was acceptable at the time of inspection though parking lines must be re-strip to identify parking spots. Parking lot striping/markings help ensure an organized flow of traffic in the parking lot. The bright lines marking out parking spaces, arrows for entrances and exits, directional flow indicators, fire lanes, and handicap line markings guide drivers and pedestrians for smooth traffic flow.

Faded lines/

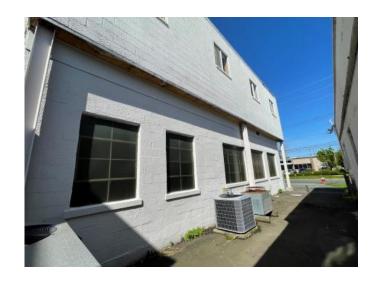
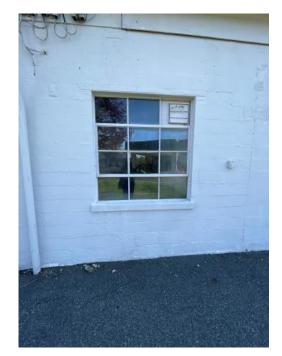
Building A, B, and C Most of the Exterior windows were uncleaned, weathering, and some deterioration was observed like broken glass and drying putty or sealant. Recommend repairs, Replace, or maintenance as needed. It is suggested that a "Licensed Contractor" be contacted for further evaluation and repair or replace.

Window outside view.

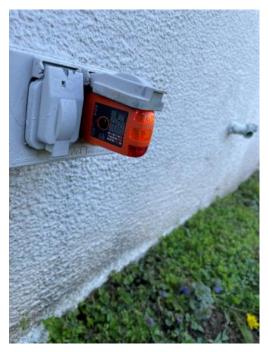
Exterior outlets appeared to be in a serviceable condition at the time of the inspection.

Exterior outlet tested.

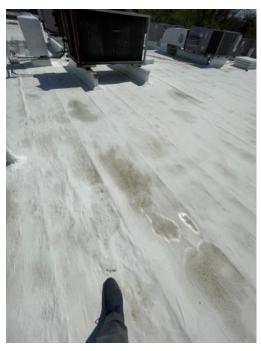
Low slope water ponding.

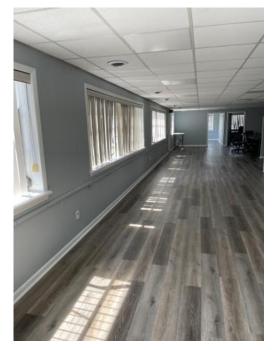
- Building B and C, Heat Pump units Inspected and was functioning at the time of the inspection.
- Building A upper floor Heat Pump units was not responding need further investigation or repair. It is suggested that a "Licensed HVAC Contractor" be contacted for further evaluation

No heating Upper level Building A.

and repair.

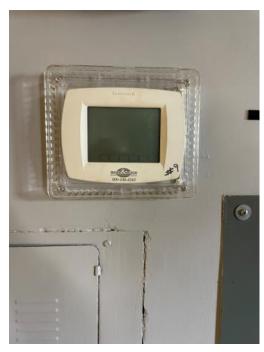
Thermostat Not responding Building A warehouse.

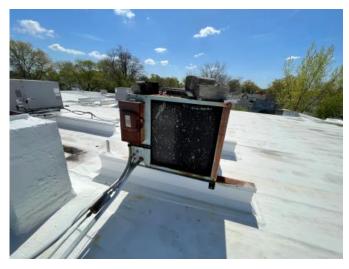
- Building **B** and Building C units were Inspected and were acceptable at the time of the inspection.
- Building A top floor Ac was not turning on or was not functioning at the time of the inspection.
- There were multiple abandoned condenser units on the roof of Building A & B and more than one abandoned unit Between Building A, B, and C. outside at ground level were observed to need to be removed though it is not an immediate concern, it is suggested to avoid burden and load on the roof and avoiding any moss to grow around these units.

Abondend Unit on Building A & B.

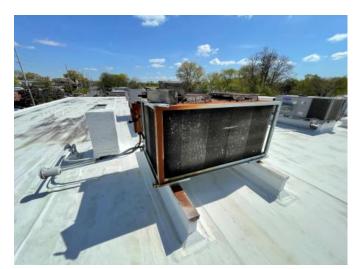
Abondend Unit.

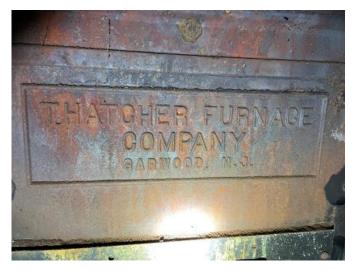
An abandoned Oil Heat or wood-burning furnace was observed in the basement.

Oil/wood Furnace.

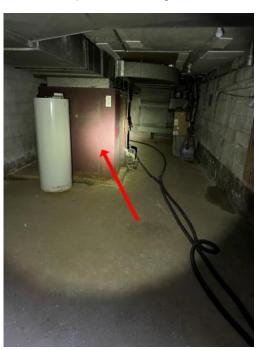
Oil/wood Furnace in the basement.

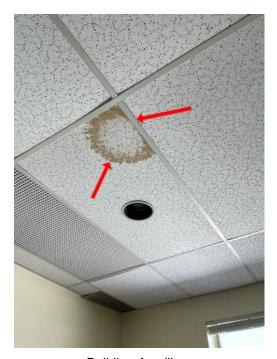
- Buildings A has Drop ceiling-type panels. The general condition of the ceilings appeared to be in a serviceable condition with water stains visible. Replace or install new panels.
- The floor coverings were damaged on the first floor of building A. Recommend repairs.
- Building A, kitchen sink faucet leaked/dripped at the time of the inspection. Repair was recommended.
- Most of the toilets were leaking or were loose in building A. Recommend repair.

- Buildings A has Drop ceiling-type panels. The general condition of the ceilings appeared to be in a serviceable condition at the time of the inspection. The inspector was unable to fully inspect the above tiles. A full inspection would require the removal of all ceiling panels, which is not performed as part of this inspection.
- Building B ceiling was Inspected and no deficiencies were noted at the time of the inspection.
- Building C ceiling was Inspected and no deficiencies were noted at the time of the inspection.

Building A ceiling.

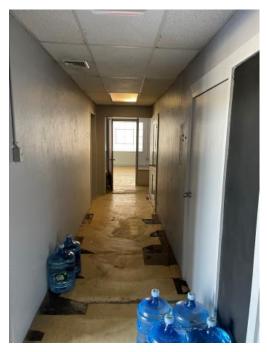
Buildings A floors, The general condition of the visible and accessible portions of the floors appeared to be in a serviceable condition at the time of the inspection. The floor coverings were damaged on the first floor of building A. Recommend repairs. It is suggested that a "Licensed General Contractor" be contacted for further evaluation and repair.

building A floors.

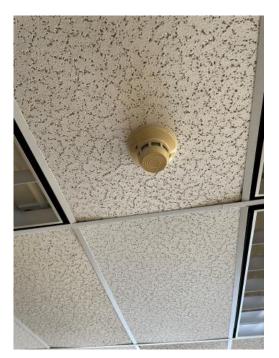
The heat detector may be part of an alarm. The heat detector was not tested. Heat detectors have a useful lifespan of about 10 years, it is recommended to replace all units after this period.

Heat detector.

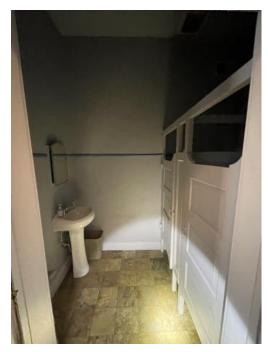
Appear serviceable at the time of the inspection. Most of the toilets were leaking or were loose in building A. Recommend repair. It is suggested that a "Licensed Plumbing Contractor" be contacted for further evaluation and repair.

Men Bathroom Building A.

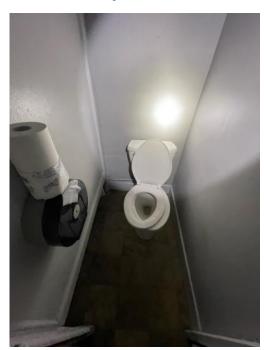
Women Bathroom Building A.

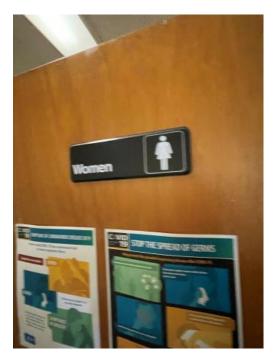
Women Toilet Building A.

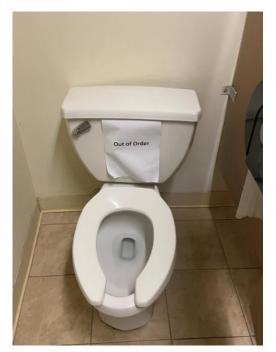
out of order.

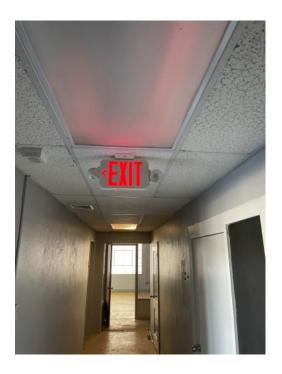
• Building A, illuminated exit signage was present and some of them were not functioning properly at the time of the inspection, it is recommended to repair or replace with new Signage with battery backups. Safety.

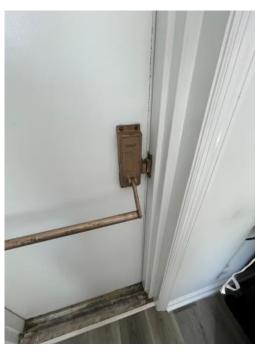
- At building A and B, There were multiple means of egress. No deficiencies were noted at the time of the inspection,
- At building B upper floor egress door lock was not functioning properly needs maintenance as needed.
 Safety.

Door lock.
